St Pauls Apartments cistern maintenance

October 2014

Spare Parts – MK1 Water Wafer Cistern

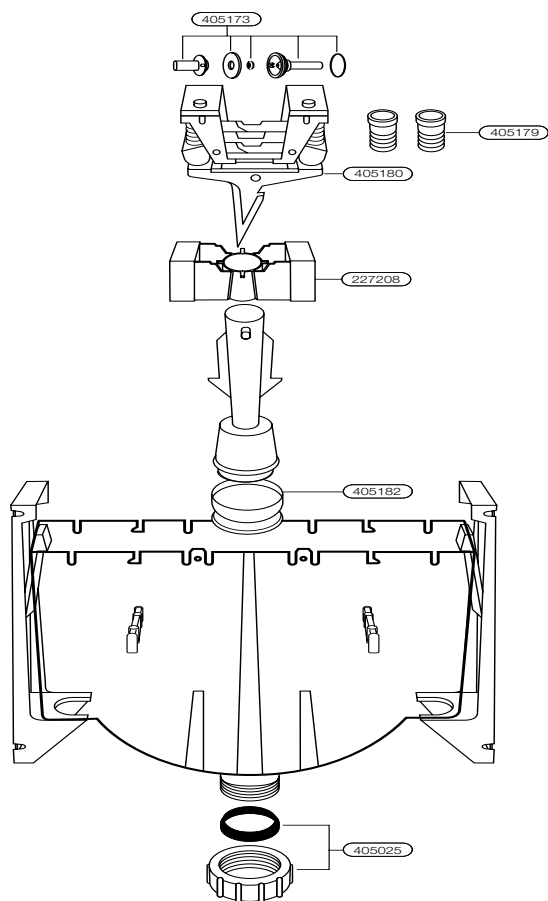
Below is a drawing of the components in our cisterns. The reason the pneumatic flush stops functioning is the rubber in one or both of the bellows cracks and can't hold enough air pressure to activate the flush. The most economic fix is to replace the whole operating mechanism.

Some leaks have been occurring as well. It has been found that the inlet valve seals are coming to the end of their serviceable life and some are now failing. To prevent water damage and the resultant costly repairs we suggest replacing the inlet valve now.

Retail component costs are:
\$70.60 for 405180 operating mechanism that includes pre-fitted bellows.
\$59.25 for 405179 2 x bellows (it is more economical to buy the whole operating mechanism as you need to remove it anyway to replace the bellows).
\$23.65 for 405173 inlet valve.
